How the MULTI/JOINT® Became a Piece of Art

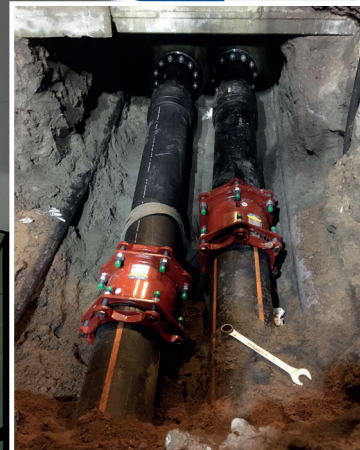
Installation
company Van
Kaam B.V. on
site. Two
MULTI/JOINTS®
3000 Plus, size
DN300, were
installed.

The MULTI/JOINT® as a solution
The water appeared to come from the heat and cold storage, which regulates the climate control of the museum. A defect to the regulator of a pump caused the pressure to increase. As a result, a gasket of a flange connection was blown off with great force. In no time liters of water filled the room and the air-conditioning was disrupted. Van Kaam was on site at 7 p.m. and the race against the clock began. A welding socket was not an option in this situation, because of the

constant water flow. MULTI/JOINT® was the best solution in this case. Two MULTI/JOINT® 3007 couplings – size DN300 – were installed by the engineers. The installation went smoothly, thanks to the ‘one-size-fits-and-grips-all-principle’. The leakage was resolved excellently and quickly.
