MULTI/JOINT® 3000 Plus

Renovation of DN600 gate valve chamber

Quick and reliable renovation of a crucial water
junction under extreme time pressure using
MULTI/JOINT® 3000 Plus and a VAG gate valve

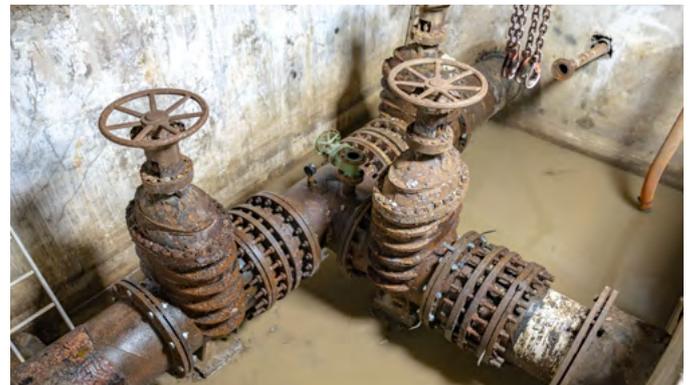
The project, commissioned by ÉRV Zrt., focused on replacing a DN600 junction and valve chamber serving a wide regional network near Miskolc. The existing installation had been in operation for over 50 years and showed clear signs of aging, increasing the risk of failure. Because the pipeline was part of an active supply system feeding twelve municipalities, shutdown time had to be kept to an absolute minimum. Furthermore, the valve chamber was flooded, and confined space made the installation process particularly challenging. That required precise planning and a controlled overnight execution schedule.

To meet the tight timeframe and challenging conditions, MULTI/JOINT® 3000 Plus fittings were chosen. The assembly included two DN600 flange adaptors with a stainless-steel pipe section, enabling a secure, precise connection between new components and the existing cast-iron pipeline. Components were supplied directly from GF distributor Interex-Waga, ensuring seamless logistics. The fittings allowed quick alignment, reliable restraint, and reduced installation risks. On-site technical support, provided by Interex-Waga, ensured smooth and confident execution by the team during the night.

Work started at 22:00 with draining and removal of the old very heavy cast-iron section. After midnight, the pre-assembled junction was lowered and quickly installed, thanks to its easy alignment. By 05:00, the system was tested, secured, and fully operational, restoring uninterrupted water supply to all twelve municipalities. The project demonstrated how careful planning, skilled installers, and flexible connection technology can dramatically reduce downtime in crucial infrastructure. The renovated junction now provides a durable, corrosion-resistant, and future-proof solution, enhancing reliability and ensuring long-term, safe water delivery for the entire service area.
