ELGEF Plus – water supply burst restored in just 24h

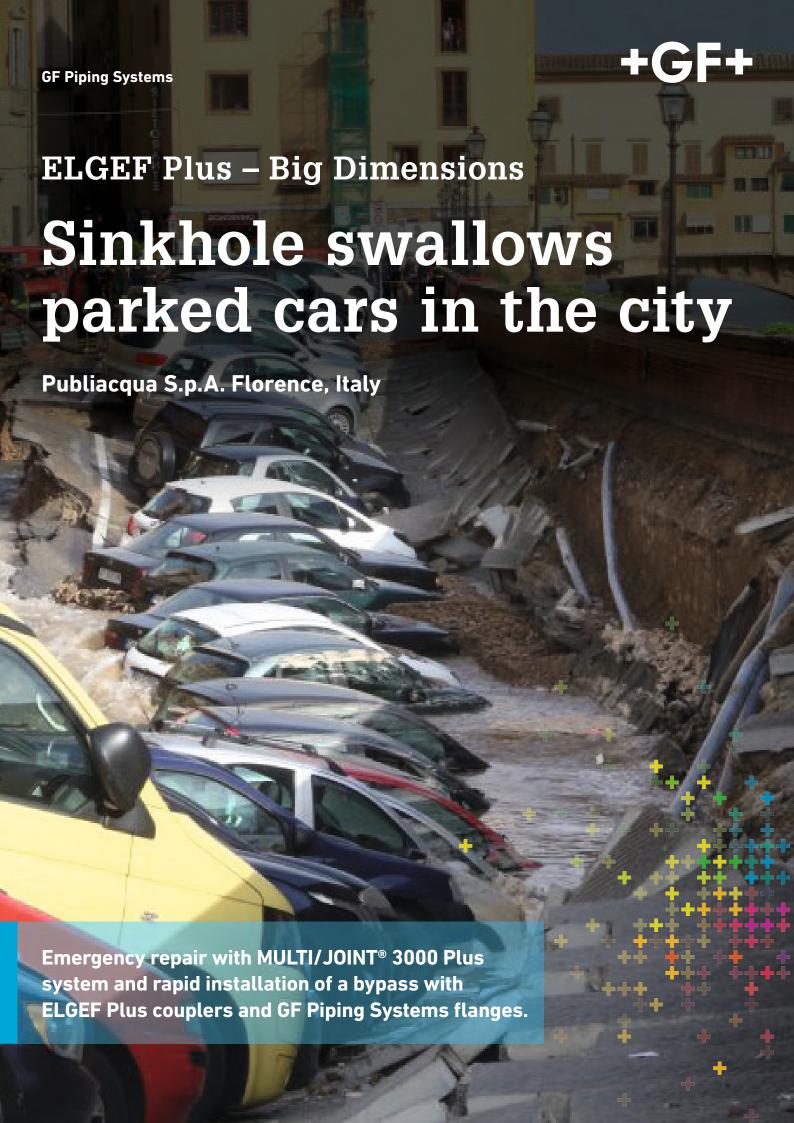
Trouble-free repair of all pipes: MULTI/JOINT® 3000 Plus.
