MULTI/JOINT[®] 3000 Plus

Quick installation in critical sewage valve replacement

Customer reference: Water Board Hollands Noorderkwartier

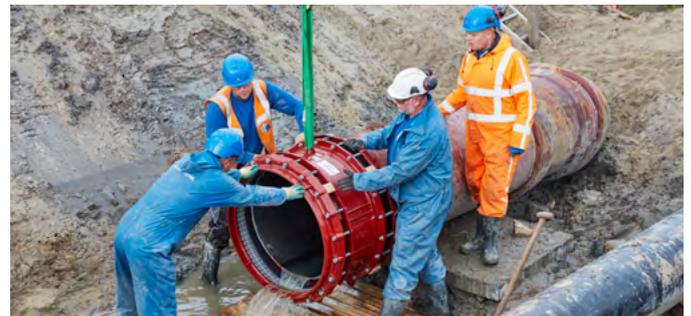
MULTI/JOINT® connects a cast iron pipe thanks to its versatile application.

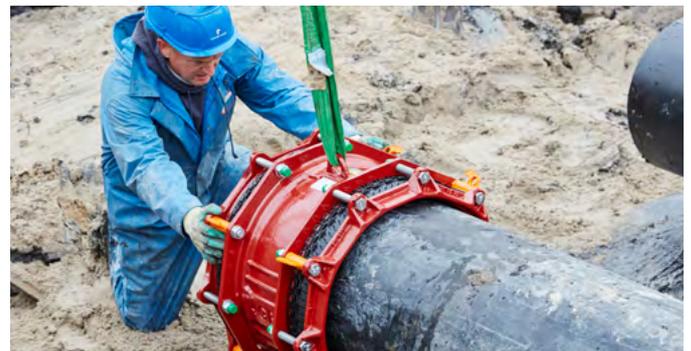
By pre-installing MULTI/JOINT® on the pipe ends, significant time was saved.
